Freeze-Thaw Resistance of Pervious Concrete

Projects in Freeze Thaw Conditions

Case Studies

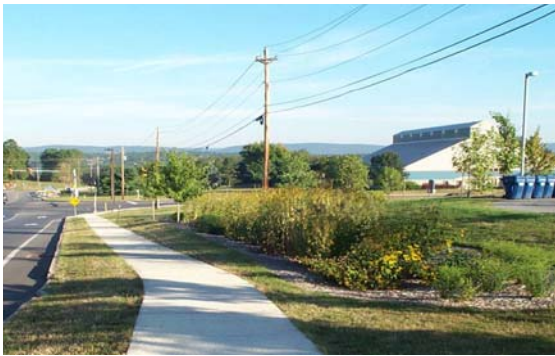
Project Name: Penn State/ Centre County Visitor Center
Engineer: Cahill Associates, Inc.
Contractor:
Ready Mixed Concrete Supplier:
Project Location: State College, PA
Year Completed: 1999

The project is a heavily used sidewalk approximately 300 feet long. There is very heavy foot traffic as it is next to a football stadium. The pervious concrete is 4” thick with an 8” large, clean-washed aggregate base on un-compacted sub grade. The location undergoes an average of about 121 cycles/year. The average daily temperature stays below freezing for 90 consecutive days (on average) and there is winter precipitation. So the climate is considered as a hard wet freeze. There is very little maintenance. The current performance is good. Mix design is based on Florida concrete association w/ cold weather additive.

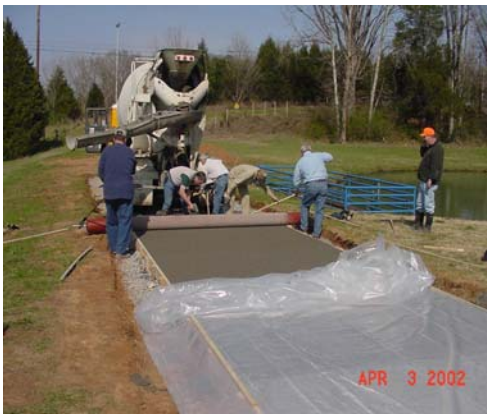
Project Name: Athens Regional Park
Engineer: Lentz & Associates, Nashville, TN
Contractor: East Tennessee Construction, Athens, TN
Ready Mixed Concrete Supplier: Cleveland Ready Mix, Cleveland, TN
Project Location: Athens, TN
Year Completed: 2003

The project involves a walking path and a parking area. The walking path has 5" of pervious concrete over a 5" stone base, on top of underlying clay soil. The parking area has 6" of pervious concrete over a 5" stone base; it includes some drainpipes. There are about 1200-1300 cubic yards in the parking area, while the walking path is 1/3 mile long. The location undergoes an average of about 90 cycles/year. However, the climate is not a hard freeze, as the average daily temperature does not drop below freezing point very often. There is precipitation during winter so the location is considered as a wet freeze. There was some vacuum sweeping after a heavy rainstorm deposited mud on the pathway. The current performance is good and there is no clogging or raveling.

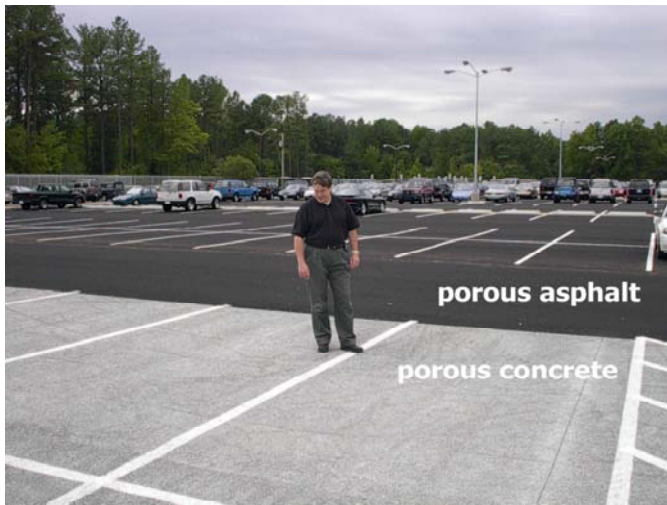
Project Name: University of North Carolina Estes Drive Commuter Lot and Friday Center Commuter Lot

This project is a heavily used commuter parking lot – 150 spaces @ Friday Ctr. and 75 spaces @ Estes. The pervious concrete is 5” thick, over an 18” large, clean-washed aggregate base on un-compacted sub grade. The project involved 1,500 cubic yards of pervious concrete and won the American Council of Engineering Companies (ACEC) – Grand Conceptor Award. The location undergoes on an average about 90 cycles/year. However, the climate is not a hard freeze, as the average daily temperature does not drop below freezing point very often. There is precipitation during winter so the location is considered as a wet freeze. There is very little maintenance. After two winters of above average freeze thaw cycles, the current performance is good. The mixture design is proprietary.

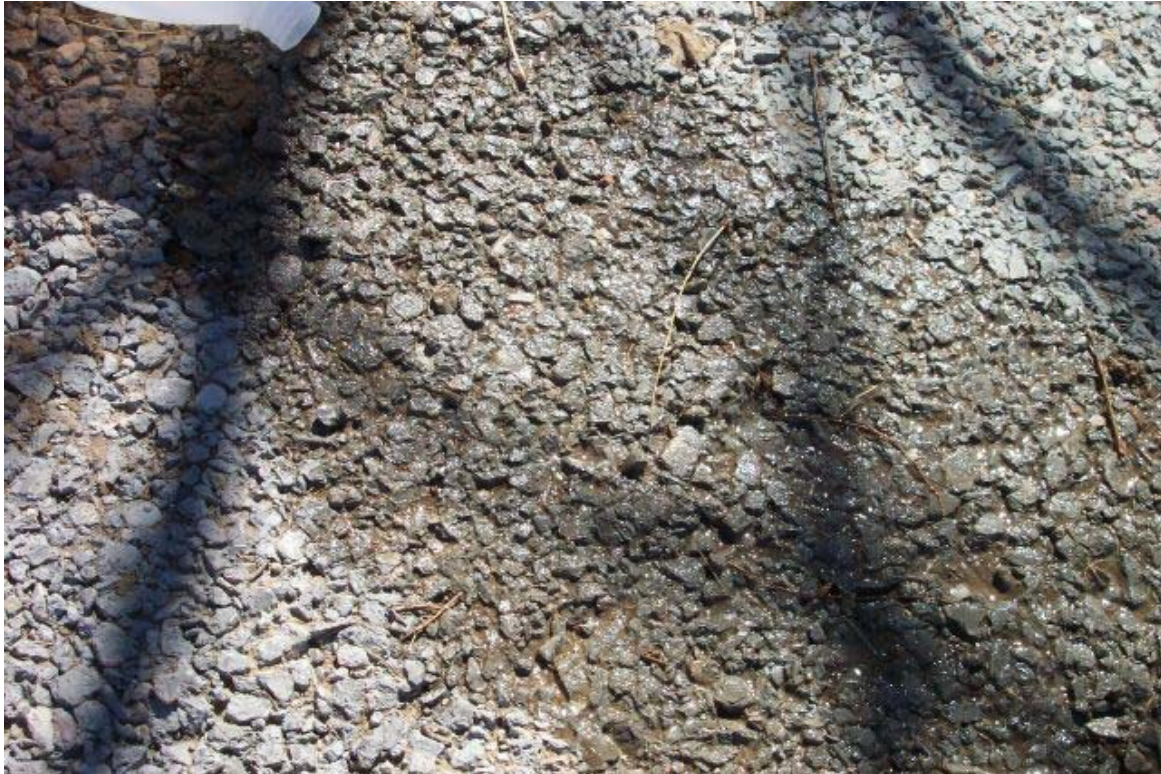
Project Name: Kozeliski’s Law Office, now DePauli engineering
First project of pervious in Gallup

The project is a parking lot for a small company. The lot is about 600 sq. yards and the traffic is pickups, SUVs and cars (all four-wheelers). The material was placed 4” to 6” thick and leveled with a regular garden rake. No drainpipes or curbs and gutters. It was compacted with a walk-behind flat plate compactor. The material was cheaper than concrete but more expensive than gravel base. The location undergoes an average of about 212 cycles/year. The average daily temperature stays below freezing for 62 consecutive days (on average) but there is very little precipitation during this period and only about 10 inches of rain throughout the year. So the climate is considered a hard dry freeze with very high freeze thaw cycling. There is no annual maintenance on this project and, after 13 years, the performance has been good. Over the past 13 years the parking lot has filled with mud that drops off the vehicles when parked. Two years ago, after a 4” rain caused flooding of the town, the parking lot had no ponded water. There are still voids to drain the water. There is some raveling of the coarse aggregate and clogging due to the mud. The parking lot has been through many snows and it has not turned into a pile of loose rock. When it was a new parking lot, the snow was pushed off and the sun came out and there was no ice build up on surface. The snow tends to melt quickly. Mixture design was cement = 300 lbs / cu.yd; coarse aggregate # 57 – 1 “ minus size 2570 lbs / cu.yd; water about 20 gals / cu.yd. Plastic unit was about 106 pcf, no entrained air or water reducer or fly ash. % void based on ASTM C-138 20 to 24 %. When filling a 4”x8” cylinder with pervious and then adding water 2” of water can be placed into the cylinder. And it

will fill the voids. Compressive strength after 28 days about 1000 psi. No special curing of the pervious. Just placed and opened for traffic.

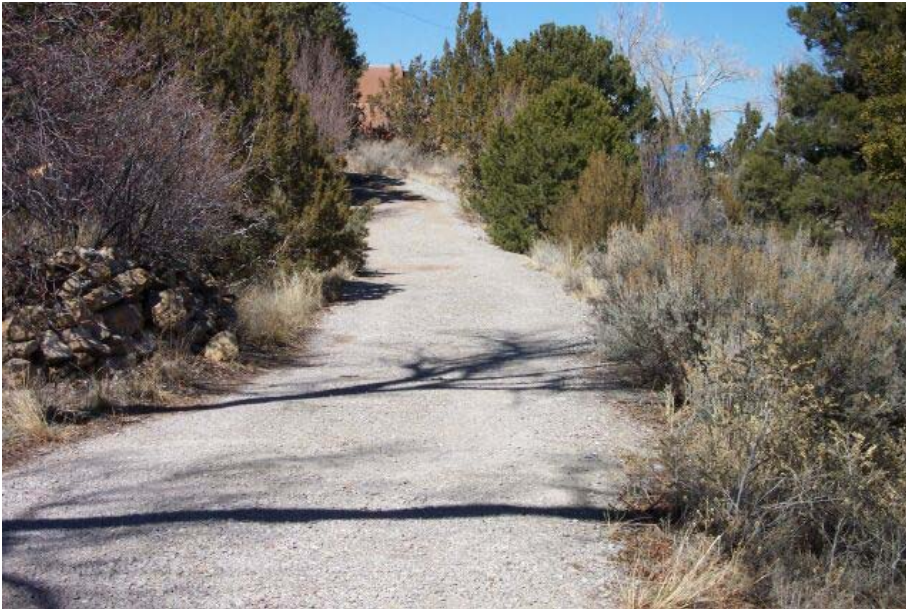
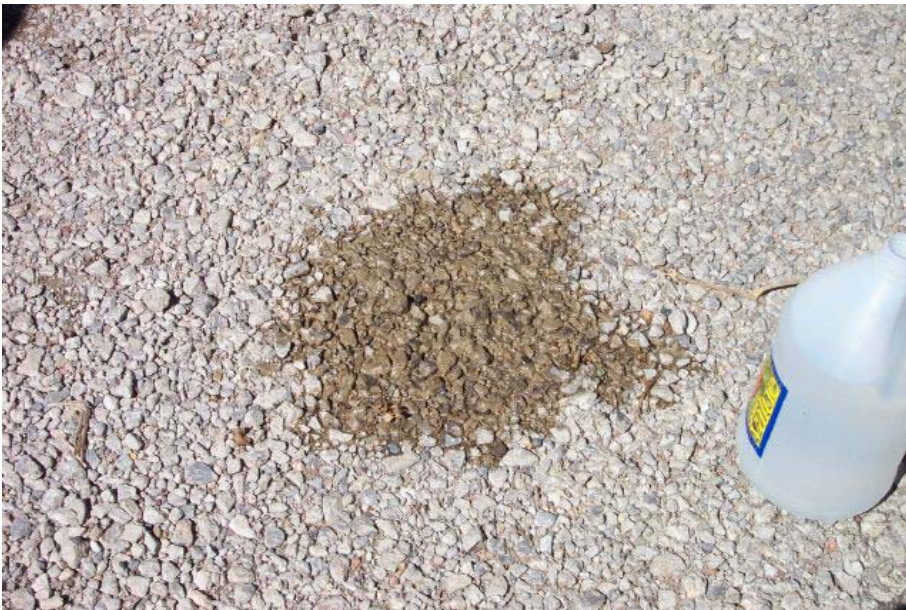
Project Name:	Milligan's Driveway.
Engineer:	Frank A. Kozeliski, P.E., F.A.C.I.
Contractor:	John Milligan and Family's Project, under the direction of Frank Kozeliski
Ready Mixed Concrete Supplier:	Gallup Sand and Gravel Co. Gallup, New Mexico
Project Location (City, State):	1326 Country Club Drive. Gallup, New Mexico N 35Degrees – 31.051' W 108D-43.780' elevation 6560 ±'
Year Completed:	October, 1993

The pervious concrete was placed as a driveway surface to keep a rustic look. The driveway is about 400 feet long and 10' wide. The traffic is pickups, SUVs, and cars (all four-wheelers), which have traveled up and down the hill every day for 11 years. The material was placed 4' to 6" thick and leveled with a regular garden rake. It was compacted with a walk-behind flat plate compactor. There are no drainpipes or curbs and gutters. The location undergoes an average of about 212 cycles/year. The average daily temperature stays below freezing for 62 consecutive days (on average) but there is very little precipitation during this period and only about 10 inches of rain throughout the year. So the climate is considered a hard dry freeze with very high freeze thaw cycling. There is no annual maintenance on this project and, after 11 years, the performance has been good. There is loose rock on the edge and some clogging where rain has caused soil to run onto the pervious. We placed a yellow color in the pervious when installed but it is not there now. The owner has a science background and is pleased with the results. The neighbors have placed base gravel twice and it continues to go down into the mud. The material was cheaper than concrete but more expensive than gravel base. Mixture design was cement = 300 lbs / cu.yd; coarse aggregate # 57 – 1" minus size 2570 lbs / cu.yd; water about 20 gals / cu.yd. Plastic unit was about 106 pcf, no entrained air or water reducer or fly ash. % void based on ASTM C-138 20 to 24 % . When filling a 4"x8" cylinder with pervious and then adding water 2" of water, can be placed into the cylinder. And it will fill the voids. Compressive strength after 28 days about 1000 psi. No special curing of the pervious. Just placed and opened for traffic.

The pervious fell apart on an incline of 10% where it was about 2” thick and cars and trucks would spin going up the hill.

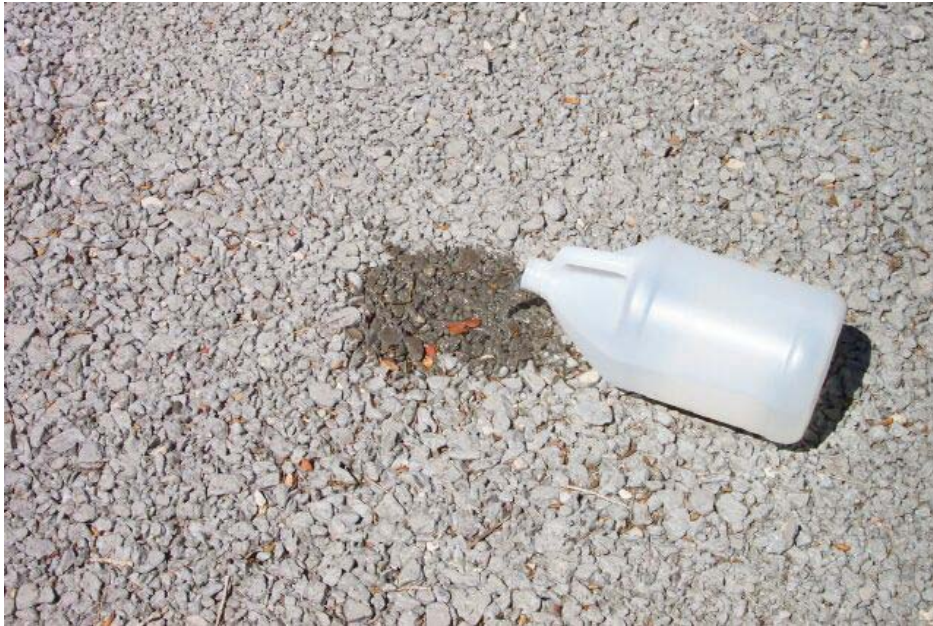
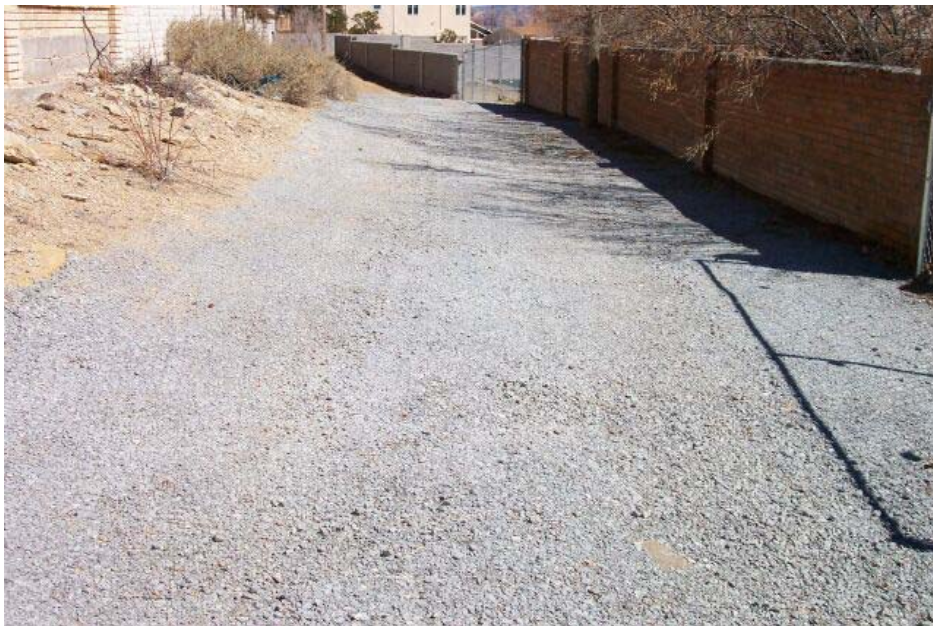
Project Name: Residential Home, George Kozeliski's Alley and Side Yard

The pervious concrete is about 400 sq. yards. The traffic is a garage truck pickup, an SUV and a dog (all four-wheelers). The material was placed 4" to 6" thick and leveled with a regular garden rake. It was compacted with a walk-behind flat plate compactor. No drainpipes or curbs and gutters. The location undergoes an average of about 212 cycles/year. The average daily temperature stays below freezing for 62 consecutive days (on average) but there is very little precipitation during this period and only about 10 inches of rain throughout the year. So the climate is considered a hard dry freeze with very high freeze thaw cycling. There is no annual maintenance on this project and, after 10 years, the performance has been good. There is more ground cover to keep the mud down and vehicles park but do not fall into the mud. Part of the pavement is on a hill and it slid some. There is one crack that we have noted. The pervious lot has been through many snows and it has not turned in to a pile of loose rock. Mixture design was cement = 300 lbs / cu.yd; coarse aggregate # 57 – 1" minus size 2570 lbs / cu.yd; water about 20 gals / cu.yd; plastic unit we about 106 pcf. No entrained air or water reducer or fly ash. % void based on ASTM C-138 20 to 24 % . When filling a 4"x8" cylinder with pervious and then adding water, 2" of water can be placed into the cylinder. And it will fill the voids. Compressive strength after 28 days about 1000 psi. No special curing of the pervious. Just placed and opened for traffic.

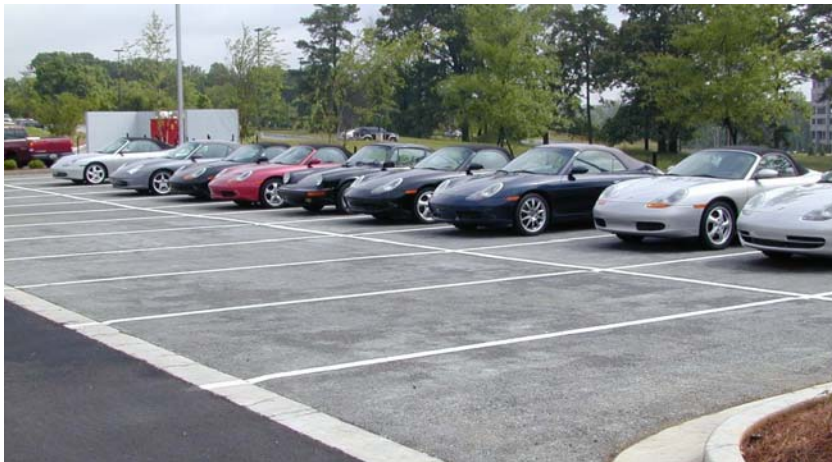
Project Name: Hennessy Porsche
Engineer: Steven L. Rowe, ASLA
Contractor: PCI Systems, LLC
Ready Mixed Concrete Supplier: Fulton Concrete
Project Location: Roswell, Georgia
Year Completed: 2003

The pervious concrete project is a Porsche dealership parking lot with a total area of 12,000 square feet. It involves 5" thick pervious concrete over 4" thick layer of #57 stone over geotextile. Curb and gutter with flush curb separating asphalt. The parking lot is in good condition and there is no annual maintenance. The location undergoes an average of about 50 cycles/year. However, the climate is not a hard freeze, as the average daily temperature does not drop below the freezing point very often. There is precipitation during winter so the location is considered as a wet freeze. There is no annual maintenance and the parking lot is in good condition. The concrete mixture design is 89 stone, no air, and 119 lb per CF.
